## **2021 Annual Report**

# **Black Donald Waste Disposal Site (A411902)**

**Township of Greater Madawaska  
County of Renfrew, Ontario**

Greenview File: 102.21.014

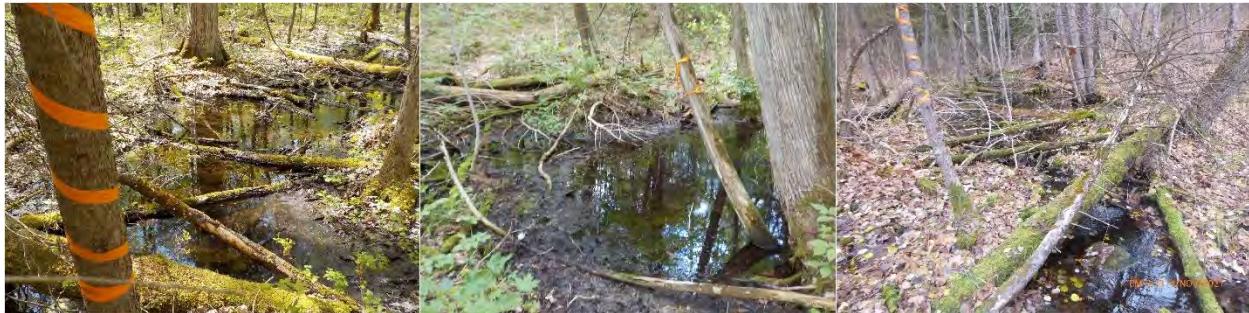
Photograph 1: Surface Water Location SW-4 (Spring, Summer, Fall 2021 [left to right])

Background surface water location SW-4 (Figure 3) is located approximately 500 metres (m) northeast and upstream of the AWDA of the Black Donald site (Figure 3). The following photographs are representative of background surface water location SW-4:

SW-4 was observed to have no discernible flow during the summer and fall 2021 sampling events (Appendix C). In 2021, some parameter concentrations at SW-4 were above 75<sup>th</sup> percentile background surface water quality at the site (Table 5). Non-conformances of PWQO, and significant trends, at background surface water sampling location SW-4 were as follows (Table 5):

In spring 2021, the concentrations of cadmium and nitrite at background location SW-4 were documented to be in non-conformance with the concentration limits of Table B of the TGD (Table 5). Consistent with historical results, surface water quality at SW-4 was interpreted to be representative of background surface water quality at the site. Background surface water location SW-4 has been observed to have historically high concentrations of phenols, phosphorus, and zinc, and low DO concentrations, attributed to naturally-occurring conditions and/or off-site sources (Table 5).

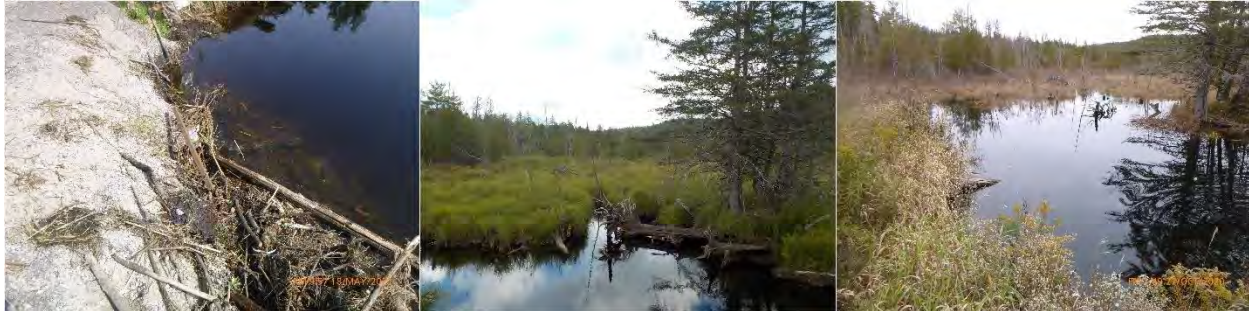
Photograph 2: Surface Water Location SW-5 (Spring & Summer 2021, Fall 2020 [left to right])

Surface water location SW-5 was relocated prior to the 2007 surface water monitoring program per MECP TSS surface water review comments (Greenview, 2008). SW-5 was relocated downstream of SW-4, at a wetland area northeast of the site. SW-5 is located at approximately the mid-point between background location SW-4 and the furthest downstream sampling location SW-3, and approximately 600 m southeast of the AWDA of the Black Donald Site (Figure 3). The following photographs are representative of surface water location SW-5:

In spring, summer, and fall 2021, no discernible flow conditions were observed at SW-5 (Appendix C). Beaver activity in the vicinity of SW-5 has historically been observed; however, no specific beaver activity was noted in the vicinity of SW-5 in 2021 (Appendix C). In 2021, some parameter concentrations at SW-5 were above 75<sup>th</sup> percentile background surface water quality at the site (Table 5). Non-conformances of PWQO, and significant trends, at surface water sampling location SW-5 were as follows (Table 5):

In spring 2021, and consistent with the non-conformance noted at background location SW-4, the concentration of nitrite at SW-5 was documented to be in non-conformance with the concentration limit of Table B of the TGD (Table 5). Historically, SW-5 has not been interpreted to be impacted by landfill related activities (Greenview, 2021), and in 2021 the noted PWQO non-conformances in results from location SW-5 were interpreted to be consistent with expected results in a no-flow, wetland environment. Surface water sampling location SW-5 was not interpreted to be impacted from landfill-related activities in 2021 (Appendix C; Table 5).

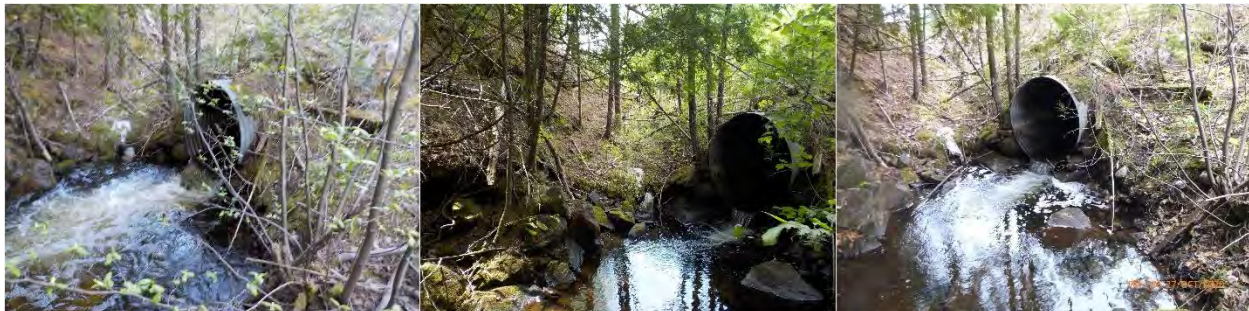
Photograph 3: Surface Water Location SW-6 (Spring & Summer 2021, Fall 2020 [left to right])

Sampling location SW-6 drains a low-lying depressional area that collects surface water drainage from the adjacent elevated topographic areas (Figure 3), and flows eastward through a cross-culvert under Hydro Dam Road. SW-6 is located approximately 1,150 m south of the AWDA of the Black Donald site (Figure 3). The following photographs are representative of surface water location SW-6:

In 2021, some parameter concentrations at SW-6 were above 75<sup>th</sup> percentile background surface water quality at the site (Table 5). Non-conformances of PWQO, and significant trends, at SW-6 were as follows (Table 5):

In spring 2021, and consistent with the non-conformance noted at background location SW-4, the concentration of nitrite at SW-6 was documented to be in non-conformance with the concentration limit of Table B of the TGD (Table 5). Historically, SW-6 has not been interpreted to be impacted by landfill related activities (Greenview, 2021). In 2021, the noted PWQO non-conformance for the concentration of phosphorus in spring 2021 was consistent with the concentration documented at background location SW-4, while the high pH value for summer 2021 was interpreted to be anomalous, as similarly high pH values have not historically been documented at SW-6 (Table 5). Results from location SW-6 in 2021 were interpreted to be consistent with typical wetland characteristics in surface water. Surface water sampling location SW-6 was not interpreted to be impacted from landfill-related activities in 2021 (Appendix C; Table 5).

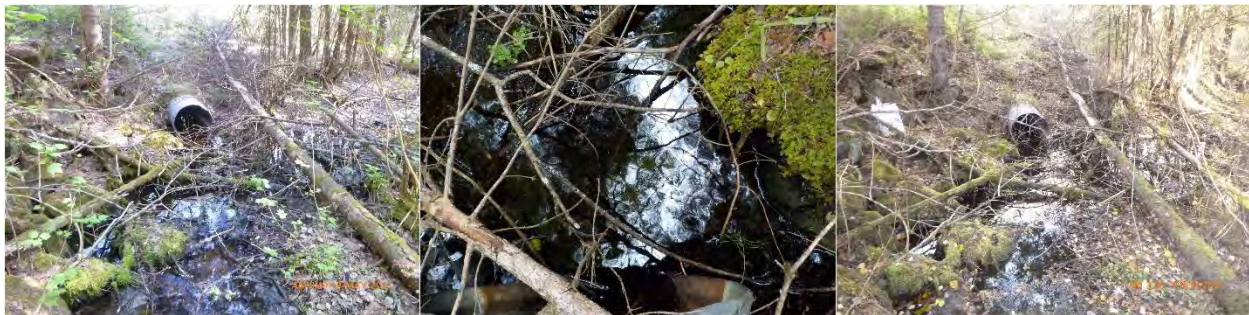
Photograph 4: Surface Water Location SW-3 (Spring, Summer, Fall 2021 [left to right])

Surface water location SW-3, located furthest downstream of the site and approximately 1,300 m southwest of the AWDA of the Black Donald site, originates from a wetland area located to the southeast of the site (Figure 3). The following photographs are representative of surface water location SW-3:

Consistent with historical observations, SW-3 was observed to be a shallow pool of water surrounded on all sides by trees and shrubs common in low-lying environments, and was observed to have no discernible flow for the summer and fall 2021 sampling event (Figure 3; Appendix C). Surface water quality results at SW-3 were generally similar to, and in most cases exhibited lower concentrations than, background surface water quality results at SW-4 in 2021 (Table 5). In 2021, few parameter concentrations at SW-3 were above 75<sup>th</sup> percentile background surface water quality at the site (Table 5). Non-conformances of PWQO, and significant trends, at surface water sampling location SW-3 were as follows (Table 5):
