2021 Annual Report

Mount St. Patrick Waste Disposal Site (A411901)

**Township of Greater Madawaska
County of Renfrew, Ontario**

March 21, 2022

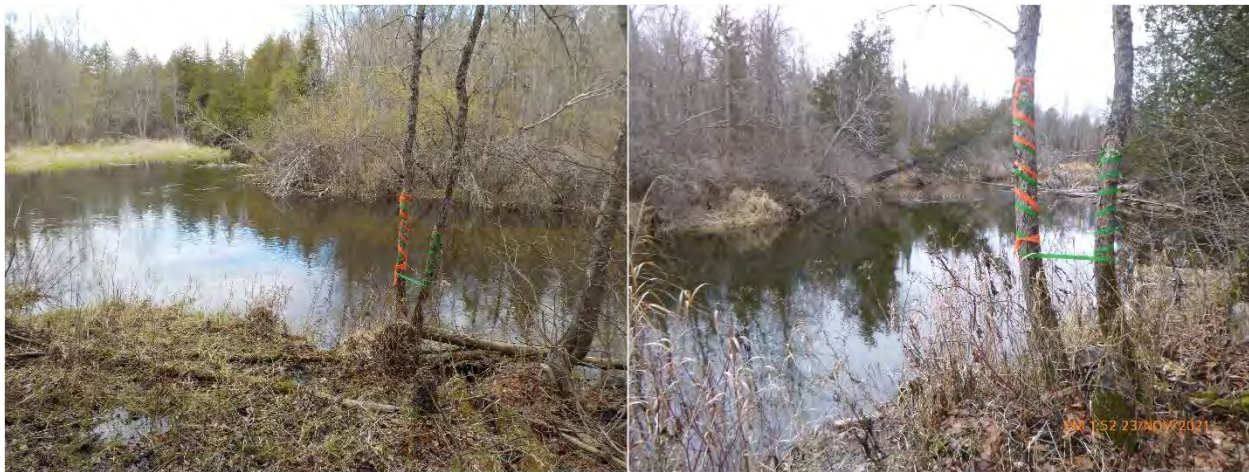
Photograph 1: Background Surface Water Location SW-2 (Spring 2021 [left], Fall 2021 [right])

In 2021, few parameter concentrations at background location SW-2 were above the 75th percentile background surface water quality at the site (Table 6). Non-conformances of PWQO, and significant trends, at background surface water sampling location SW-2 were as follows (Table 6):

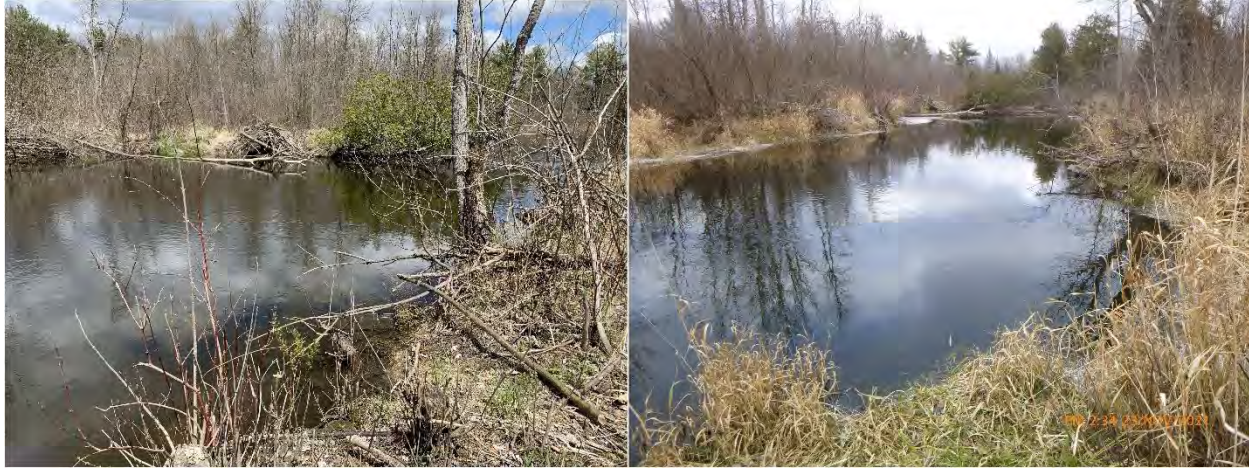
Photograph 2: Surface Water Location SW-4 (Spring 2021 [left], Fall 2021 [right])

Few parameter concentrations at SW-4 were above the 75th percentile background surface water quality at the site for the spring and fall 2021 sampling events (Table 6). Non-conformances of PWQO, and significant trends, at surface water sampling location SW-4 were as follows (Table 6):

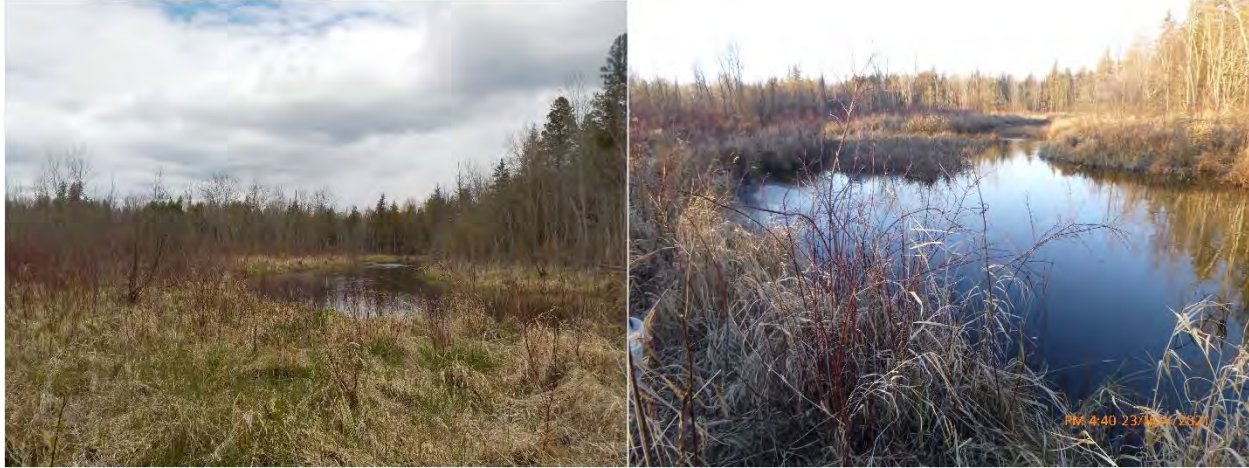
Photograph 3: Surface Water Location SW-1 (Spring 2021 [left], Fall 2021 [right])

In 2021, few parameter concentrations at SW-1 were above the 75th percentile background surface water quality at the site (Table 6). Non-conformances of PWQO, and significant trends, at surface water sampling location SW-1 were as follows (Table 6):

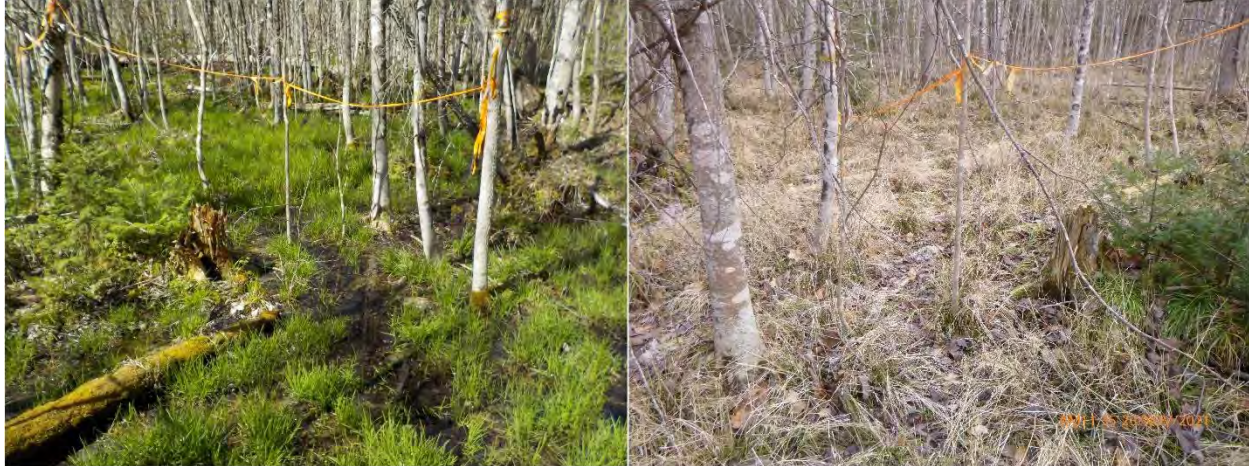
Photograph 4: Surface Water Location SW-3 (Spring 2021 [left], Fall 2021 [right])

Samples were not collected from SW-3 during the fall 2021 monitoring event as the sampling location was observed to be dry (Appendix E; Figure 3), while no discernible flow conditions were observed at location SW-3 during the spring 2021 sampling event (Appendix E). Beaver activity was observed in the vicinity of SW-4 during the spring 2021 sampling event (Appendix E).

Non-conformances of PWQO, and significant trends, at surface water sampling location SW-3 were as follows (Table 6):
